# New Hampshire Volunteer Lake Assessment Program

## 2003 Biennial Report for Rust Pond Wolfeboro

NHDES Water Division Watershed Management Bureau 29 Hazen Drive Concord, NH 03301

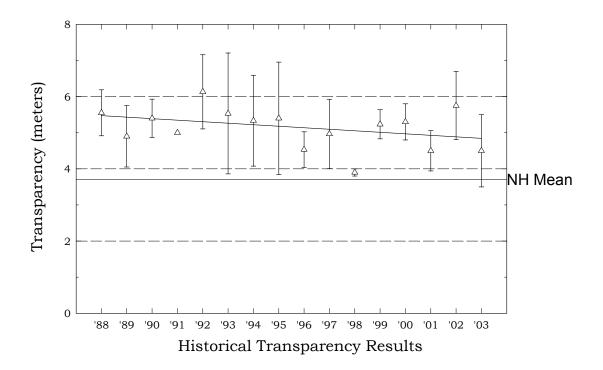
2003 Transparency Results

The current year data (the top graph) show that the in-lake transparency *increased* from June to July, and then *decreased* from July to August. The transparency in June was *approximately equal* to the state mean while in July and August the transparency was *greater than* the state mean.

The bottom graph shows historical annual mean transparencies. In 2003, the mean transparency was *greater than* the state mean.

Overall, the statistical analysis of the historical data (the bottom graph) show that the mean annual in-lake transparency has **not significantly changed** (either *increased* or *decreased*) since monitoring began in **1988**. Specifically, the in-lake transparency has remained **relatively stable** and has been **greater than** the state mean. (Note: Please refer to Appendix E for the statistical analysis explanation and data print out.)

Typically, high intensity rainfall causes erosion of sediments into lakes/ponds and streams, thus decreasing clarity. Efforts should continually be made to stabilize stream banks, pond shorelines, disturbed soils within the watershed, and especially dirt roads located immediately adjacent to the edge of tributaries and the pond. Guides to Best Management Practices designed to reduce, and possibly even eliminate, nonpoint source pollutants, such as sediment loading, are available from DES upon request.

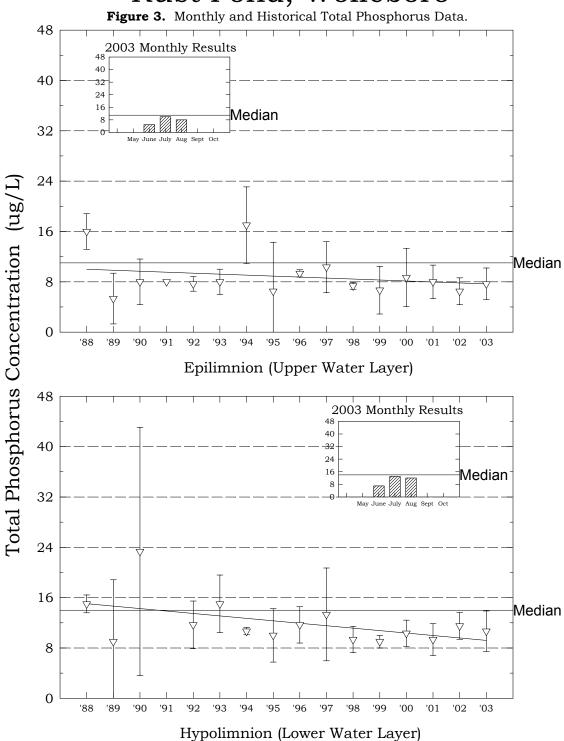
The current year data for the epilimnion (the top inset graph) show that the phosphorus concentration *increased* from June to July, and then *decreased* from July to August. The phosphorus concentration in June, July, and August was *less than* the state median.

The top graph shows historical annual mean epilimnetic phosphorus concentrations. In 2003, the mean epilimnetic phosphorus concentration was *less than* the state median.

The current year data for the hypolimnion (the bottom inset graph) show that the phosphorus concentration *increased* from June to July, and then *slightly decreased* from July to August. The phosphorus concentration in June, July, and August was *less than* the state median.

The bottom graph shows historical annual mean hypolimnetic phosphorus concentrations. In 2003, the mean hypolimnetic phosphorus concentration was *less than* the state median.

Overall, the statistical analysis of the historical data show that the phosphorus concentration in the epilimnion (upper layer) and the hypolimnion (lower layer) has **not significantly changed** (either *increased* or *decreased*) since monitoring began in **1988**. Specifically, the phosphorus concentration in the epilimnion and hypolimnion has remained **relatively stable** and has been **less than** the state median. (Note: Please refer to Appendix E for the statistical analysis explanation and data print out.)

One of the most important approaches to reducing phosphorus loading to a waterbody is to continually educate watershed residents about its sources and how excessive amounts can adversely impact the ecology and value of lakes and ponds. Phosphorus sources within a lake or pond's watershed typically include septic systems, animal waste, lawn fertilizer, road and construction erosion, and natural wetlands.
